**RE: Site Assessment/Engineering Analysis Report**

# St. Albertus Church

## ENGINEERING SITE ANALYSIS

2050 E Canfield Street  
Detroit, MI

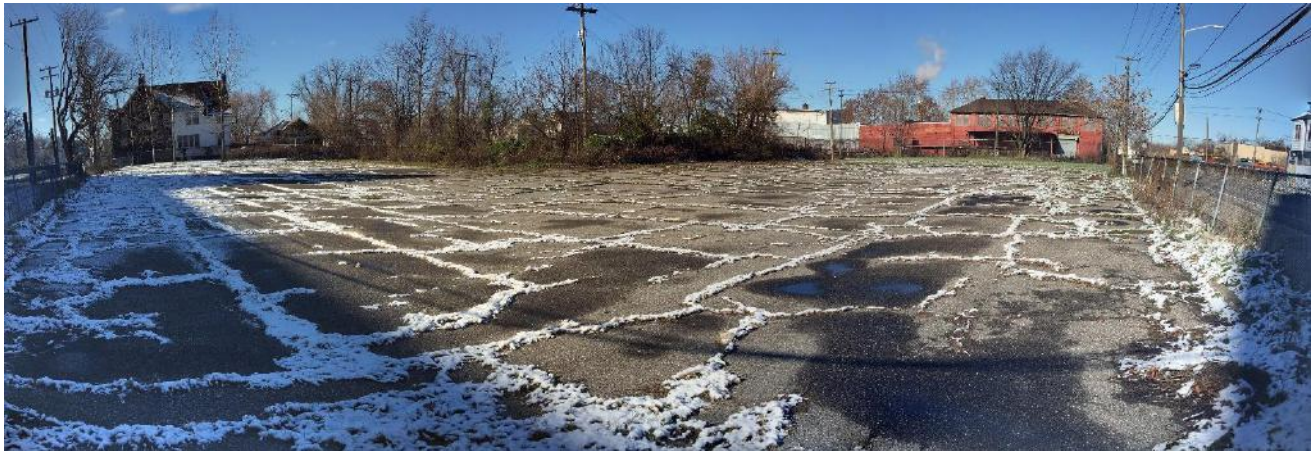
**Image 1: The church-owned parking lot across from the church building. Practice 1 is proposed surrounding the existing catch basin in the center of the lot, to intercept runoff from the parking lot.**

**Proposed Practice 1** is located in the middle of the parking lot parcel north on the northwest corner of Canfield and St Aubin St. It will intercept the runoff from the entire parking lot. Once within Practice 1, stormwater will discharge at a restricted rate to the DWSD sewer through the existing catch basin. Prior to implementation, it should be verified whether the catch basin in the parking lot connects to the DWSD sewer in the alley or in E Canfield St. If the catch basin connects to the alley, the GSI practice may need to be re-oriented and some of the parking spaces reconfigured.

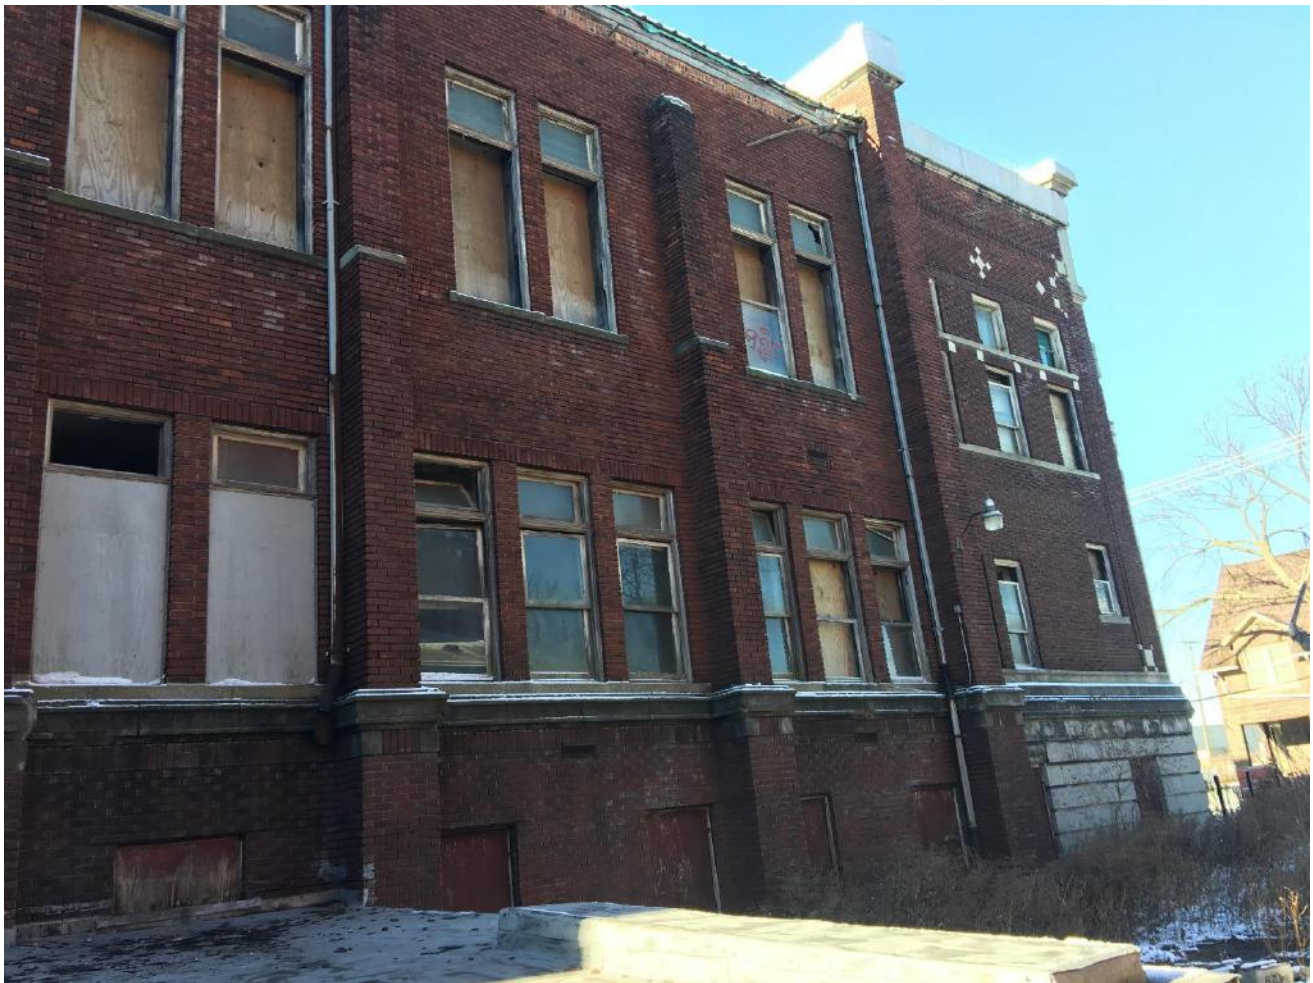
**Image 2: The west side of the abandoned school building. Some downspouts appear to be missing (such as the one in the foreground) and some still look connected (background). The runoff from this portion of the building would be directed to proposed Practice 2.**

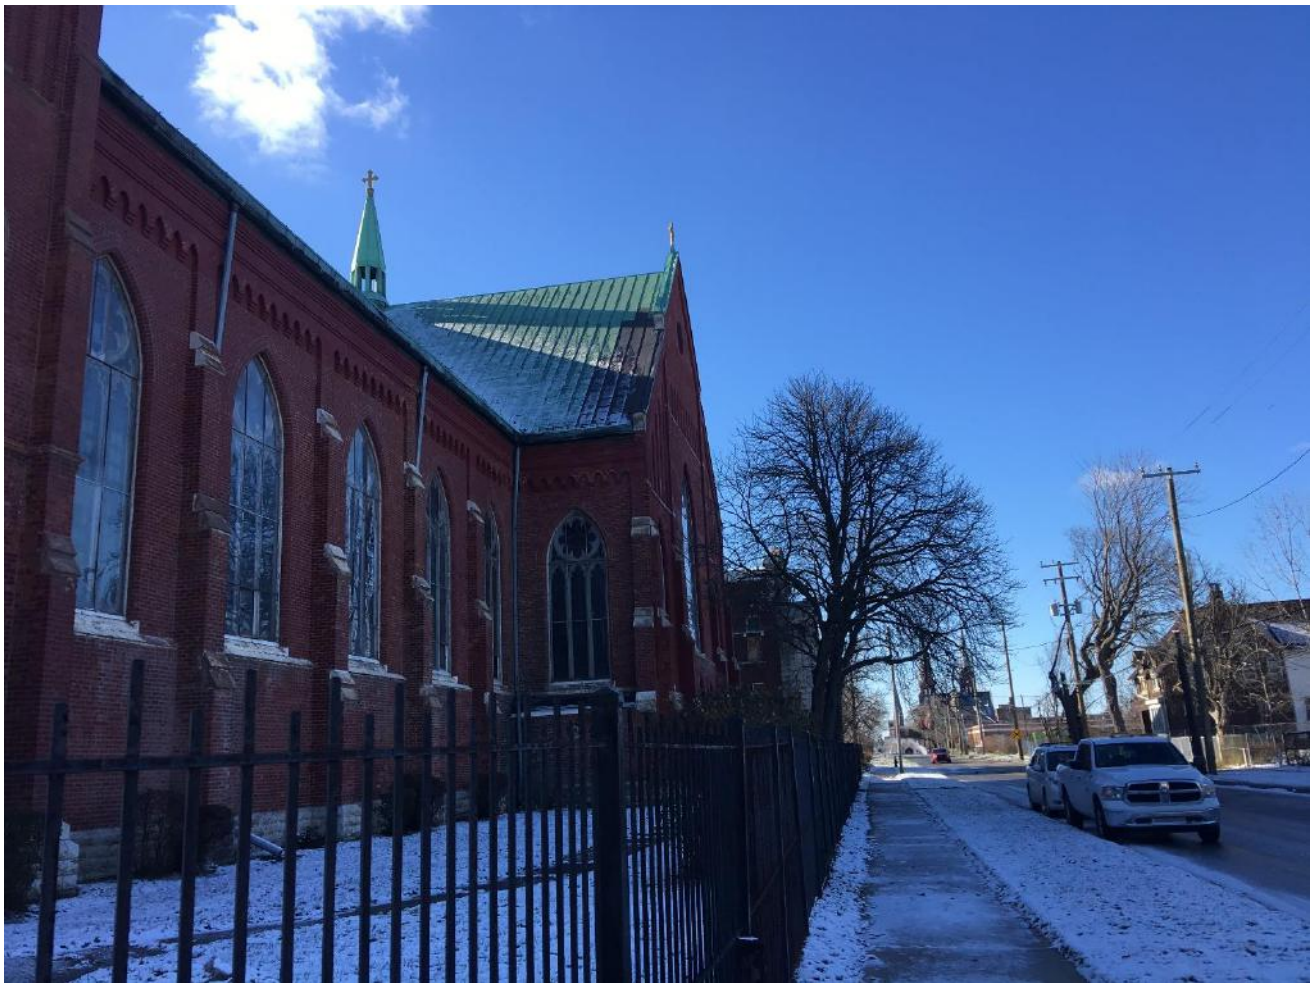
**Image 3: The church building from the north corner of the church building property, looking down E Canfield Street. Practice 3 is proposed between the fence and the church building and would intercept runoff from the visible portions of the church roof.**

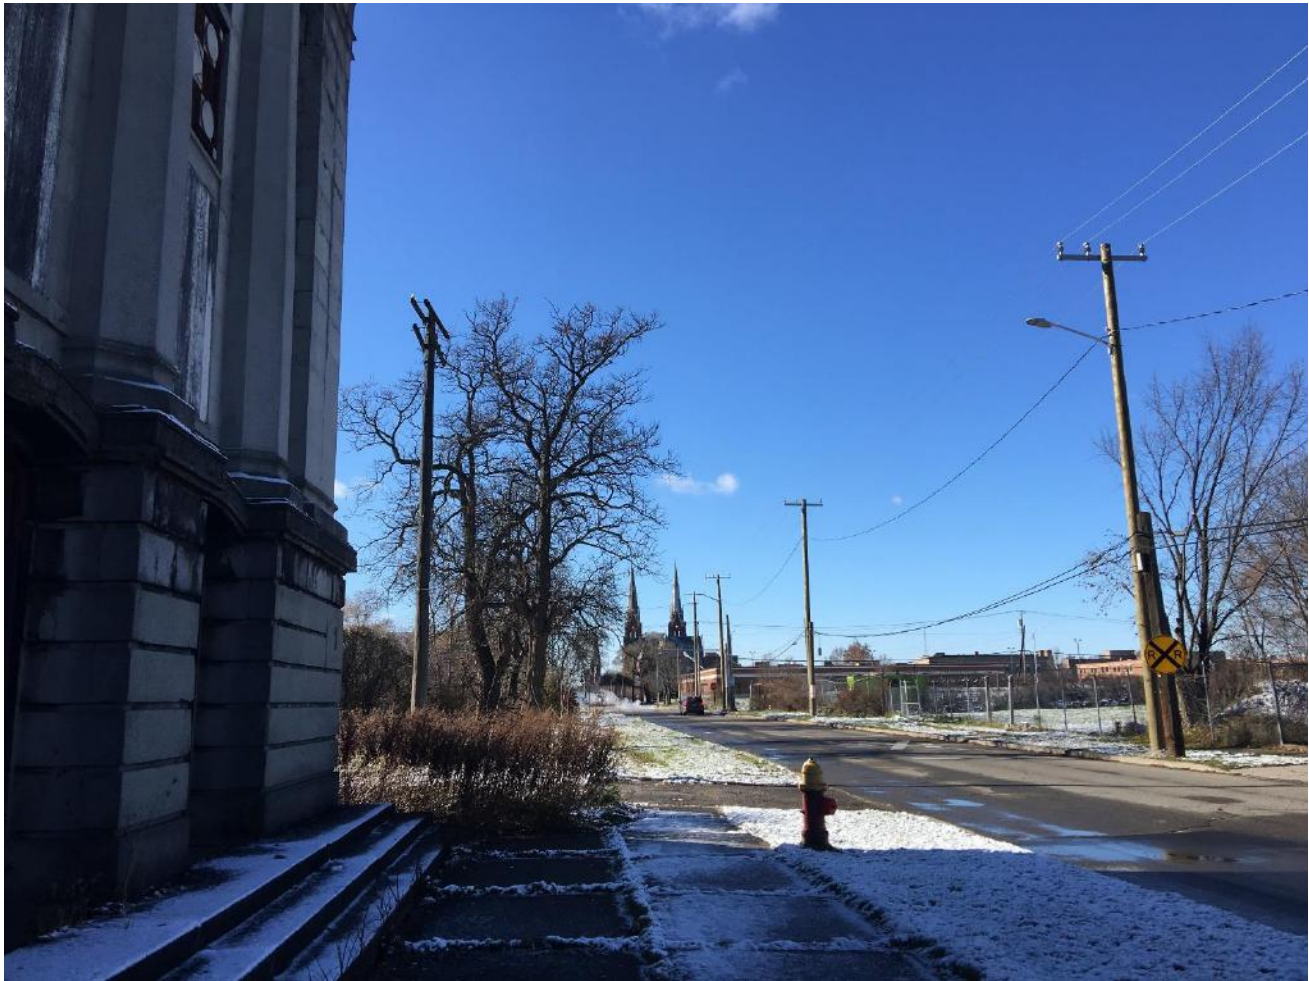
**Image 4: Looking away from the church property past E Canfield St side of the abandoned church building. Some pavement removal is recommended here between the sidewalk and the steps of the building.**

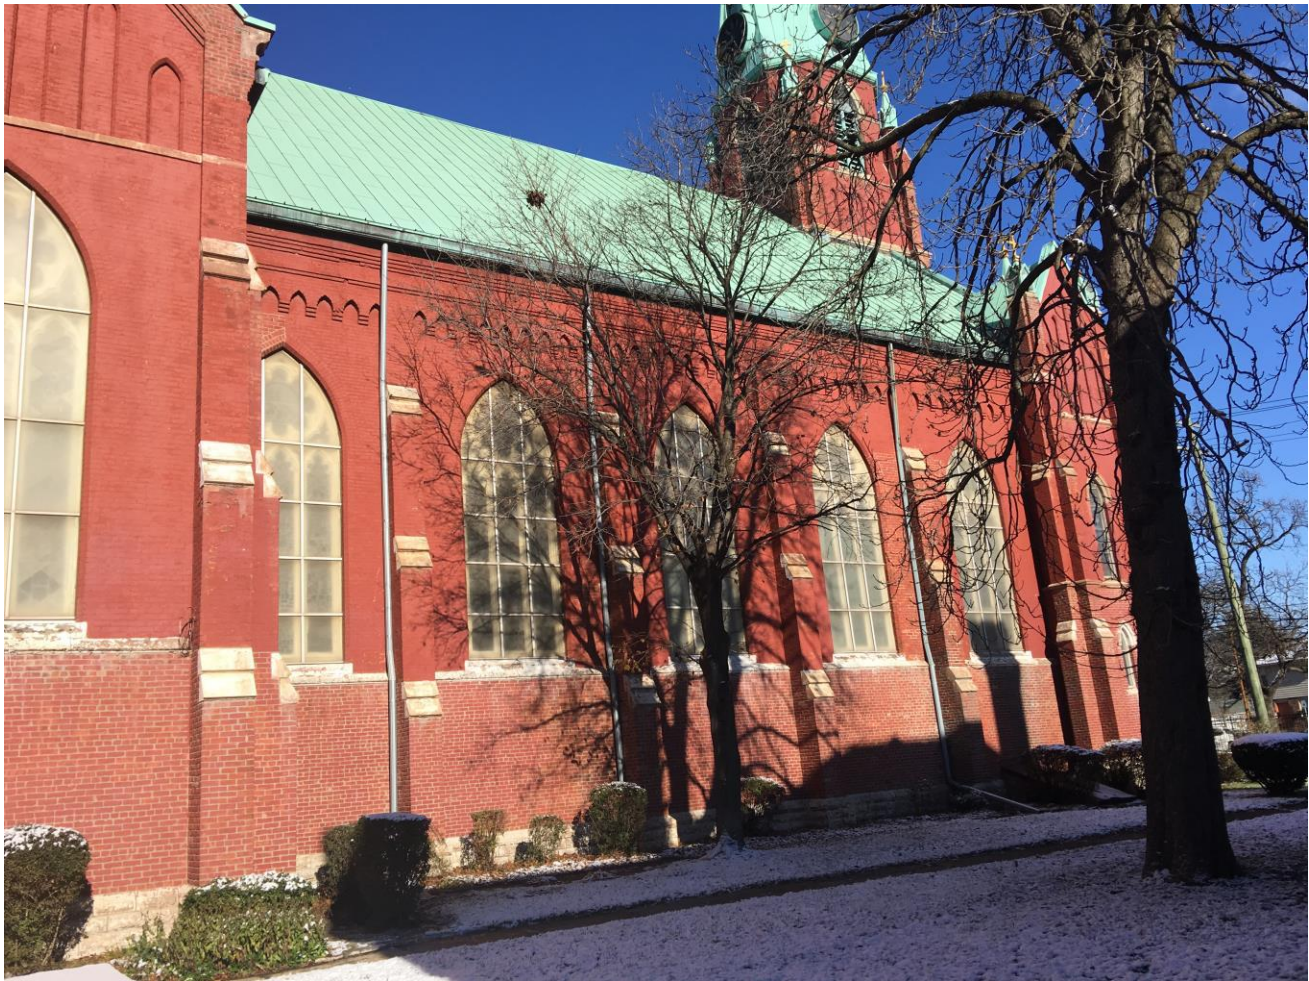
**Image 5: The southeast side of the church has several downspouts; some are disconnected and some may be connected. These would be directed to proposed Practice 4.**

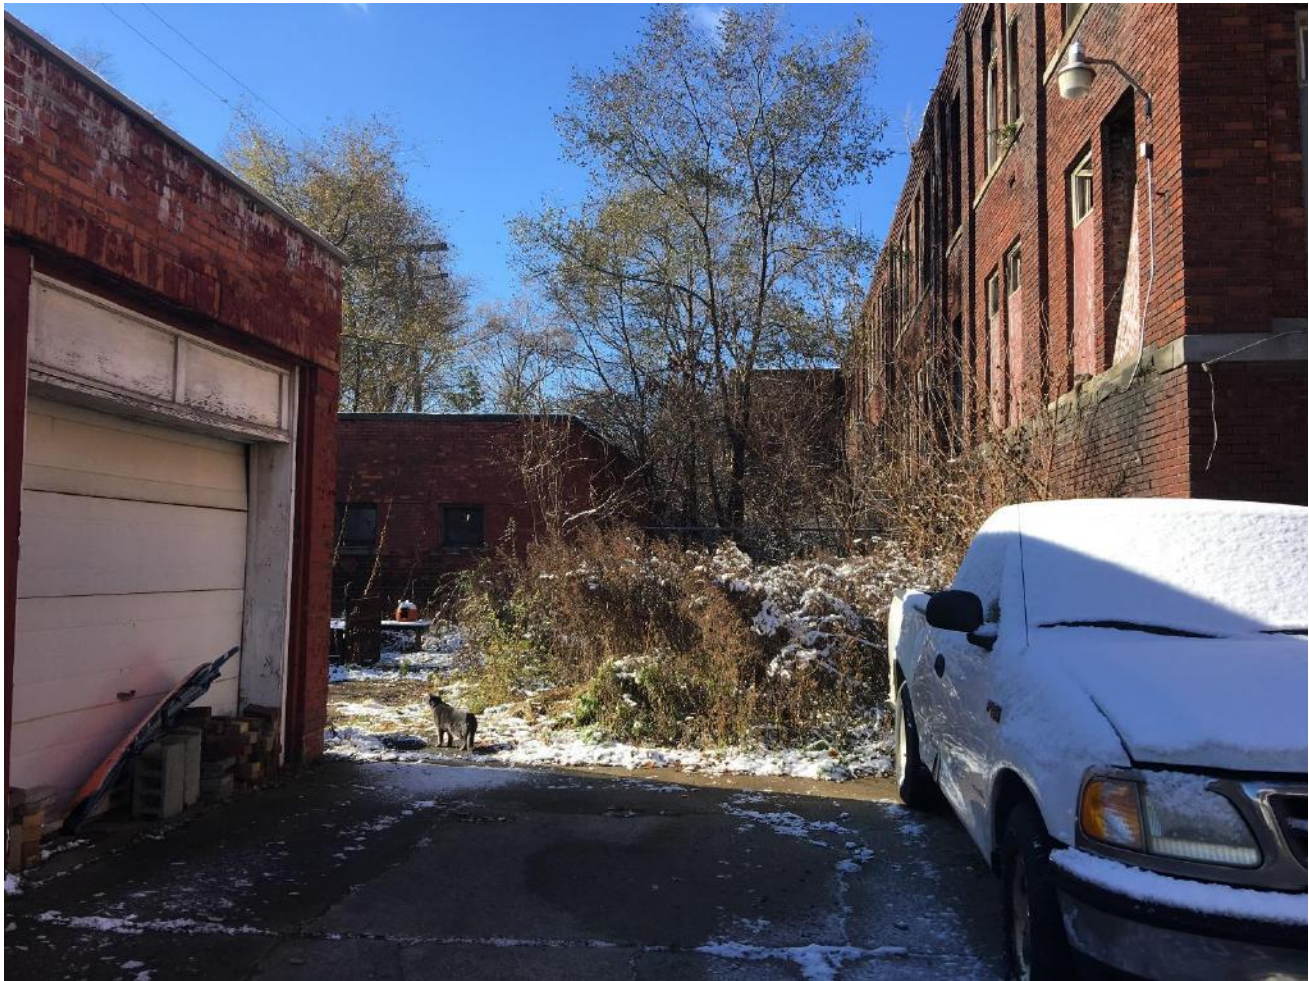
**Image 6: View into the back of the abandoned school building. The garage is on the left, other structures in the background. Practice 5 proposes the south half of the abandoned school building as disconnected impervious due to the impervious area behind it.**

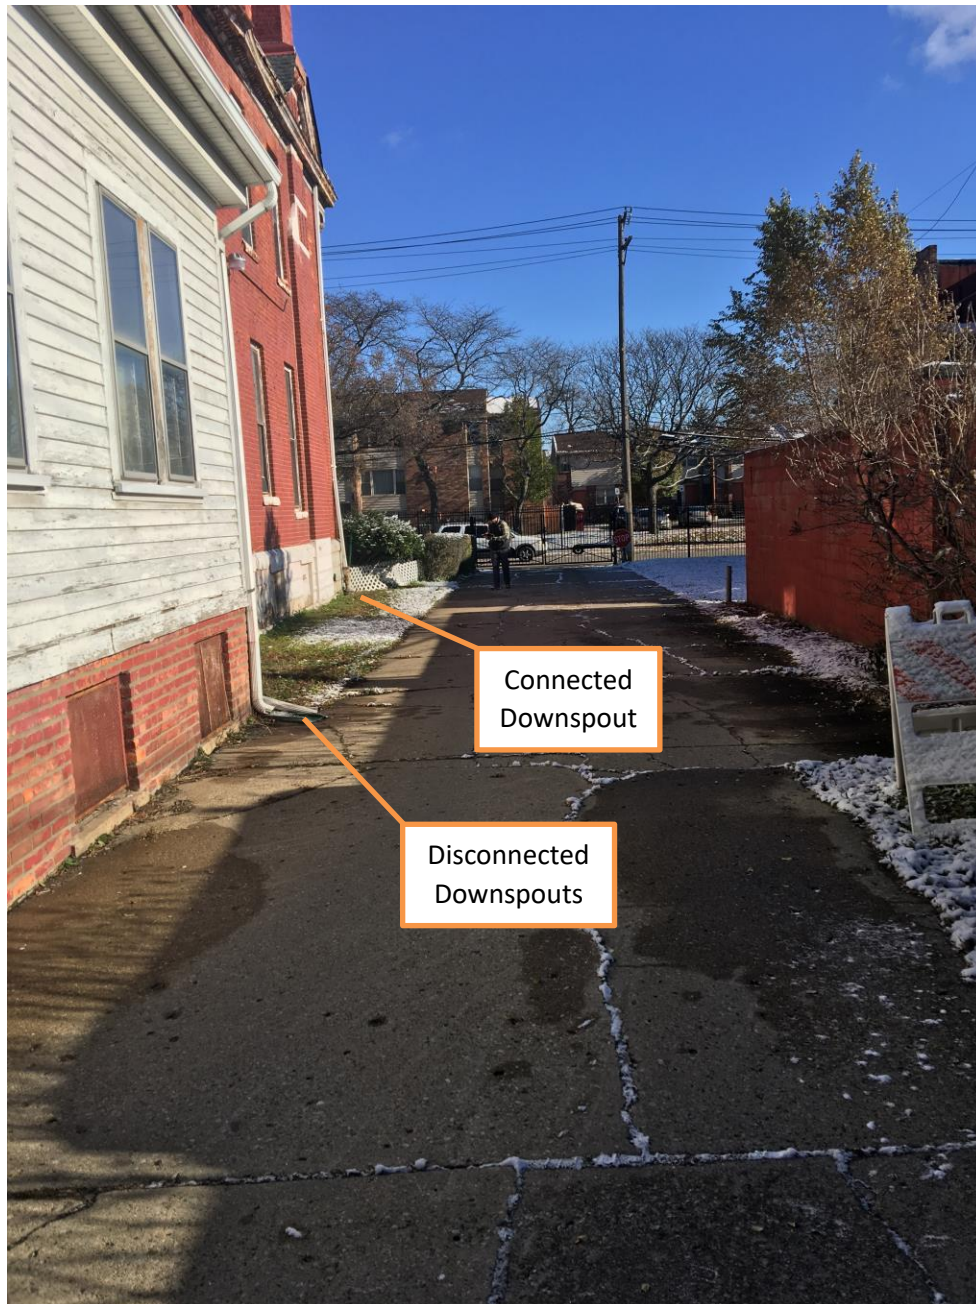
**Image 7: Disconnected downspouts and connected downspouts are both found on the property, as shown here on the rectory. If a shared practice was implemented with Joseph Frontera & Son, it could be located to the right of the pictured driveway.**

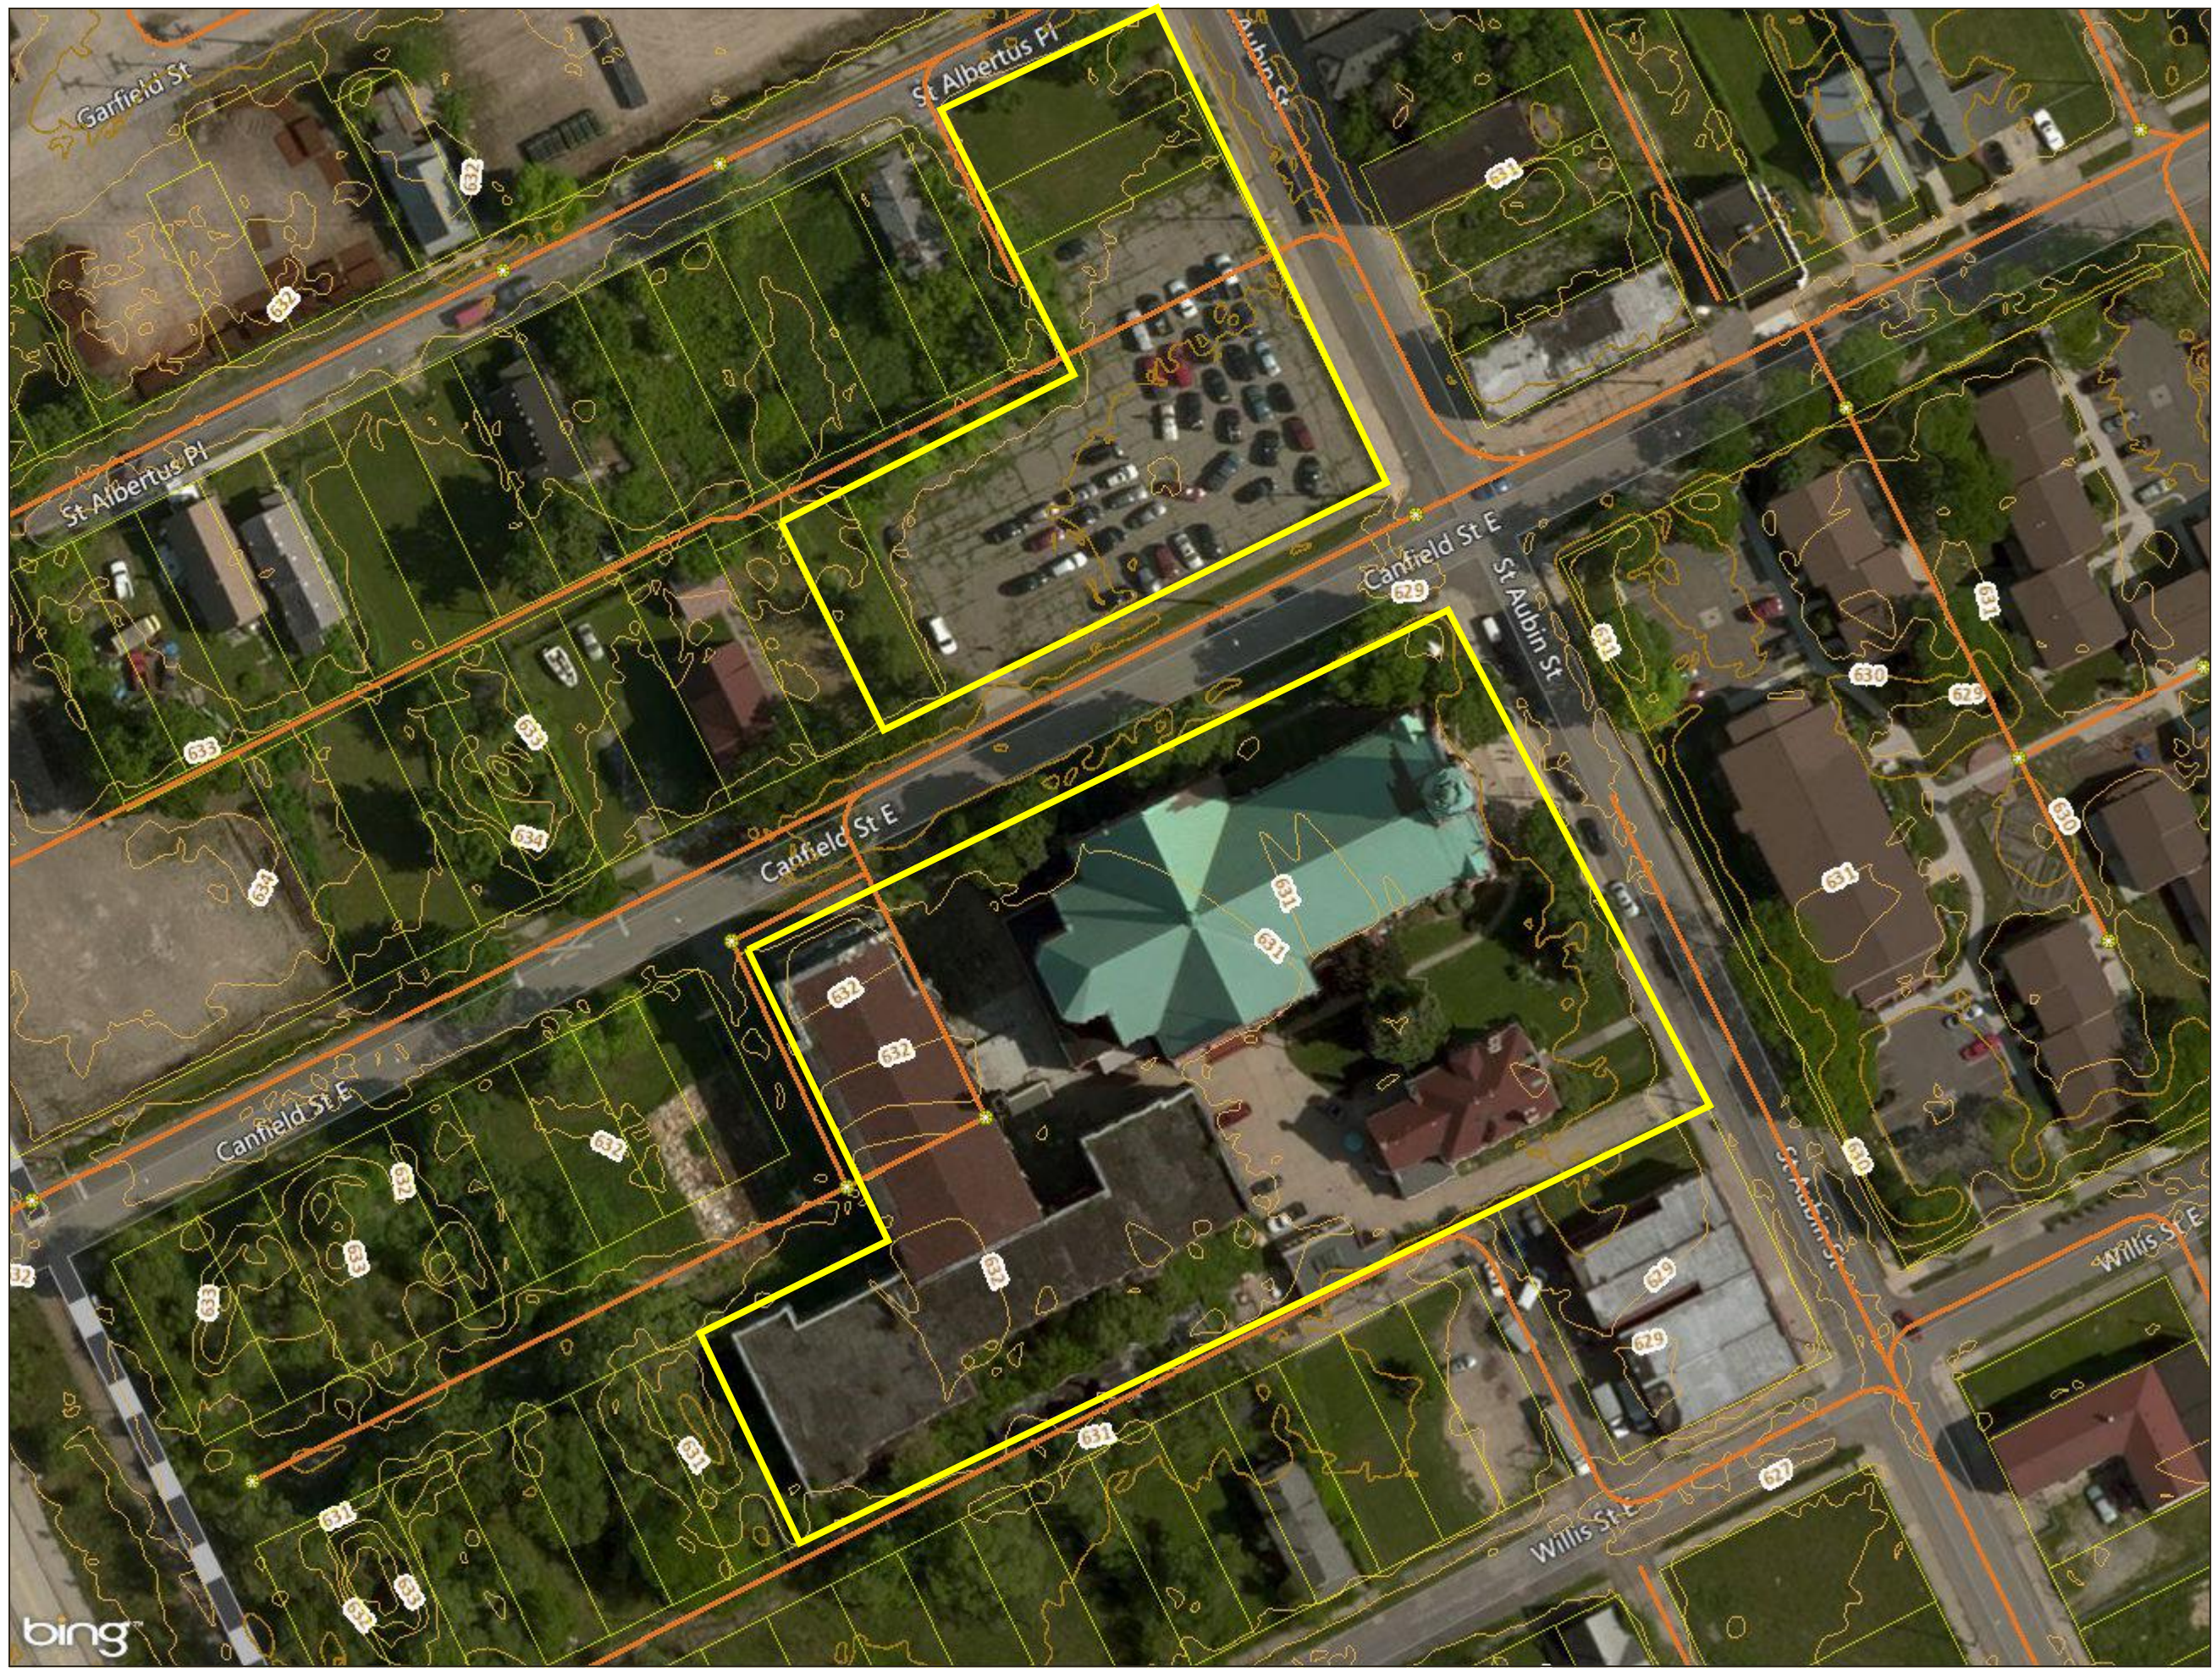
### Environmental Impairments GIS Map

- Manhole
- Gravity Main
- Parcels
- DWSD\_GI\_OneFootContours - 94
- 1
- 0

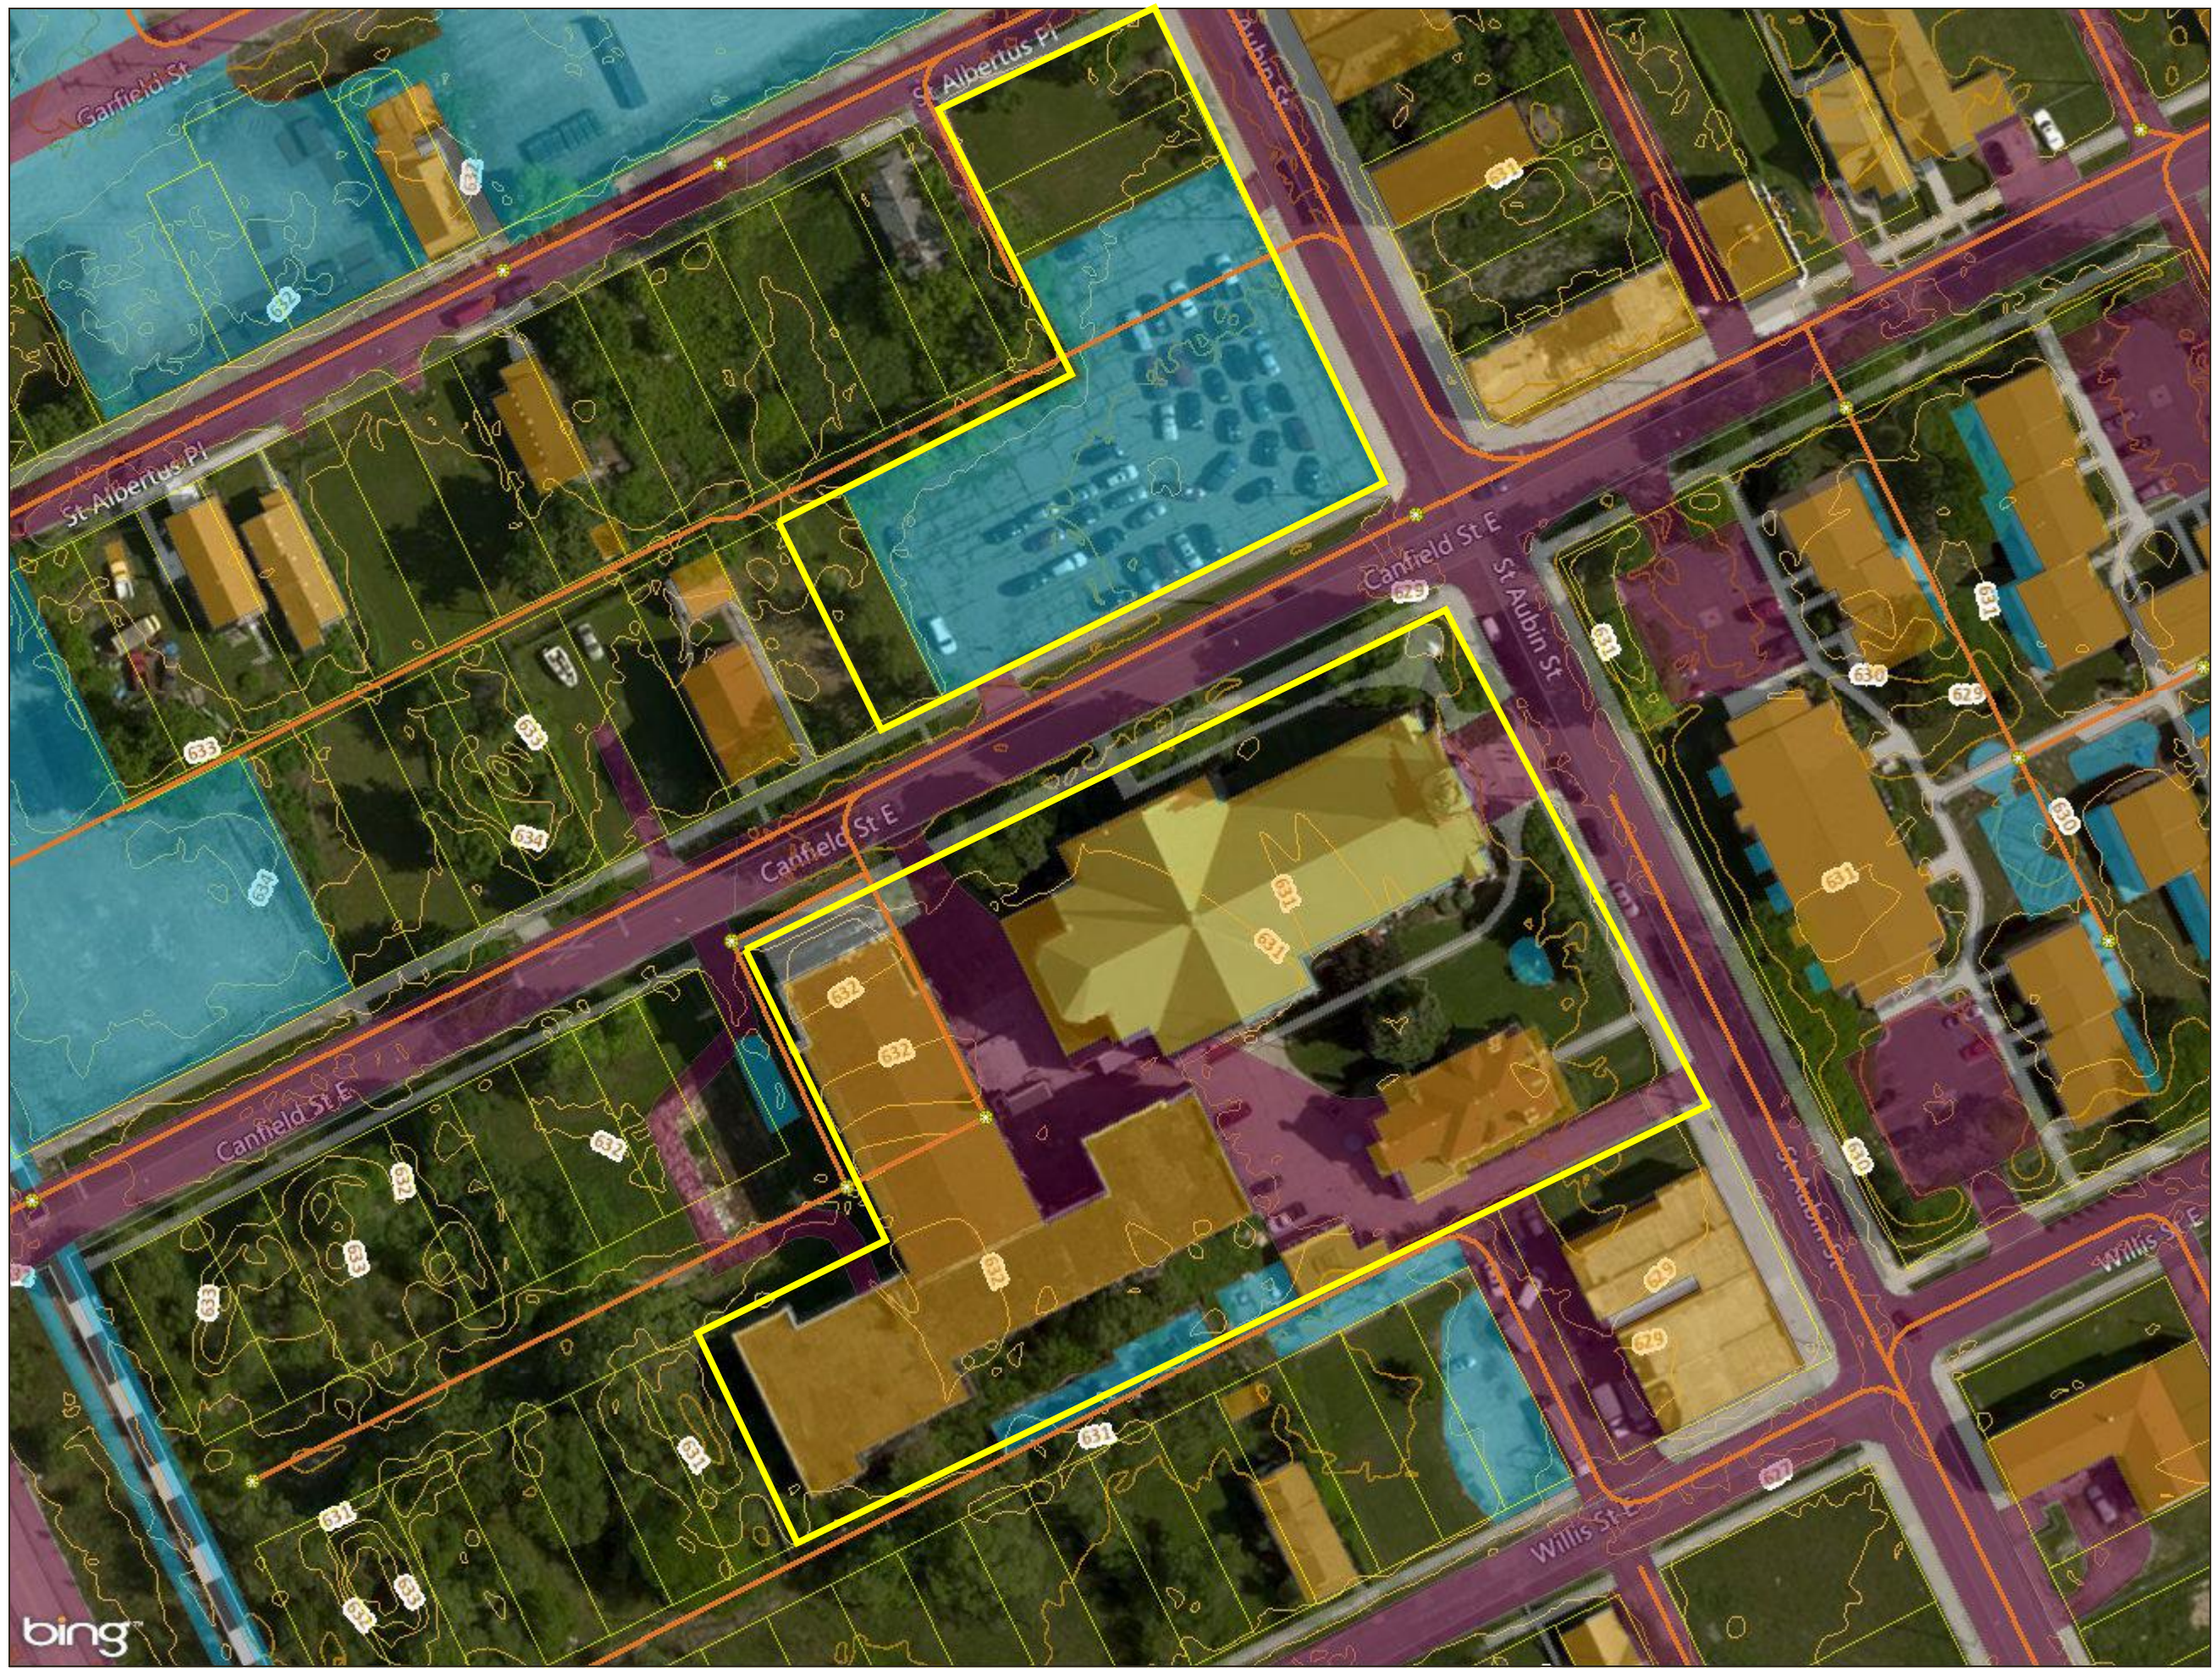
### Existing Impervious GIS Map

- Manhole
- Gravity Main
- Parcels
- Detroit Impervious 2015**
  - Pavement
  - Buildings
  - Sidewalks
  - Other
- DWSD\_GI\_OneFootContours - 94**
  - 1
  - 0
